Designated Substances Survey – North Kawartha Health Centre -183 Burleigh Street, Apsley, Ontario

June 24, 2026

Prepared for:
Township of North Kawartha

Cambium Reference: 20498-001

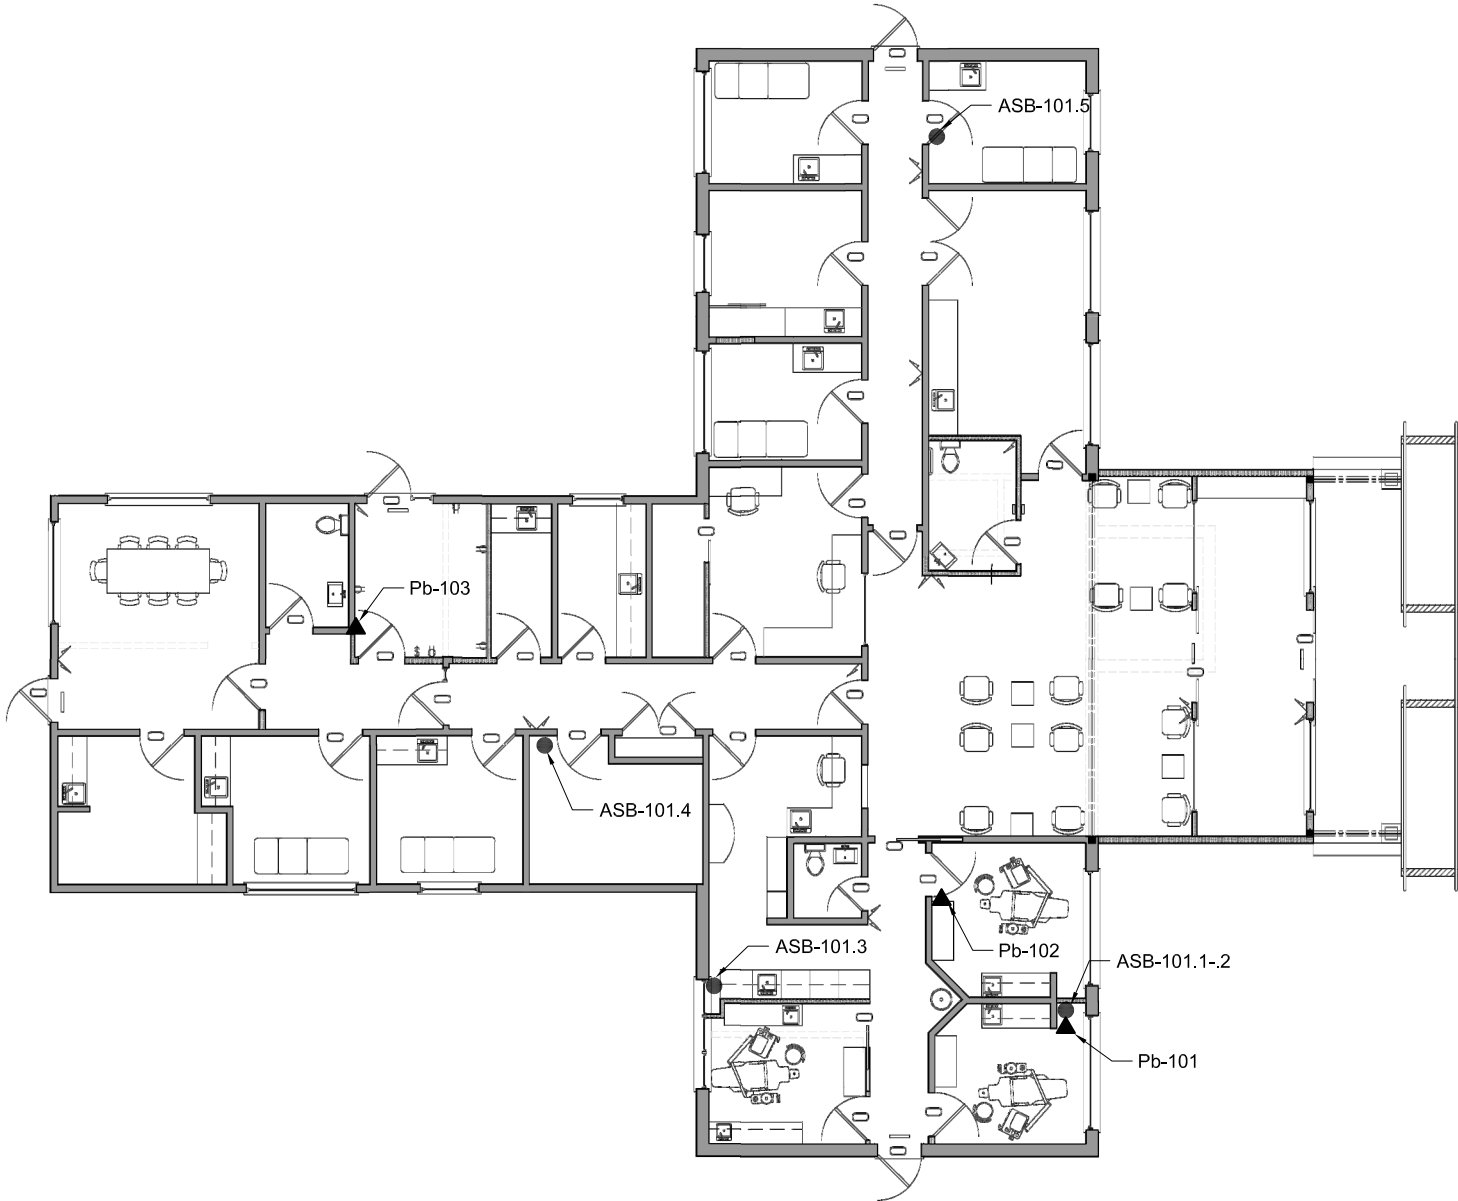
SITE PLAN

Below is a brief summary of building materials identified during the assessment that were suspected of being asbestos-containing. Photographs are included in Appendix A. The laboratory certificate of analysis report for asbestos is included in Appendix B. A drawing with the locations of samples is present in Figure 1.

The following Table 1 summarizes the laboratory results for the bulk samples of paint collected for lead analysis. The laboratory certificate of analysis report for lead is included in Appendix C. A drawing with locations of samples is present in Figure 1.

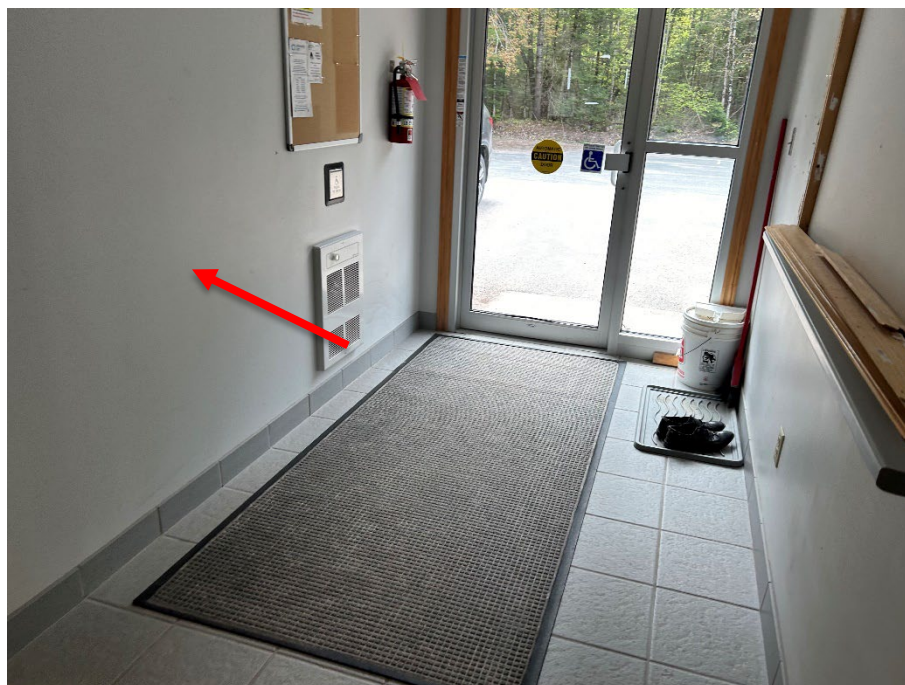
Non-asbestos drywall joint compound is present on gypsum wall and ceiling finishes throughout building (samples ASB-101.1 to ASB-101.5).

Photo 1 – Non-asbestos drywall joint compound.
